| <b>Test Report Number :</b> RJ9246F-2 | <b>Date:</b> May 31, 2024 |

**SAMPLE ID:** The client identified the following test material as:  
Moso Bamboo Thermo decking board.

**TEST REQUESTED:** Evaluate the client's Decking Board system in accordance to CSFM Title 24 12-7A-4.8- which outlines testing to be conducted using the procedures and methods outlined in 709A.1.4.1. " San Diego County Building Code".

**TEST RESULTS:** The submitted deck material has met the requirements of San Diego County Building Code per condition of acceptance Section 709A.1.4.1.5. Detailed test results are provided on the following page.

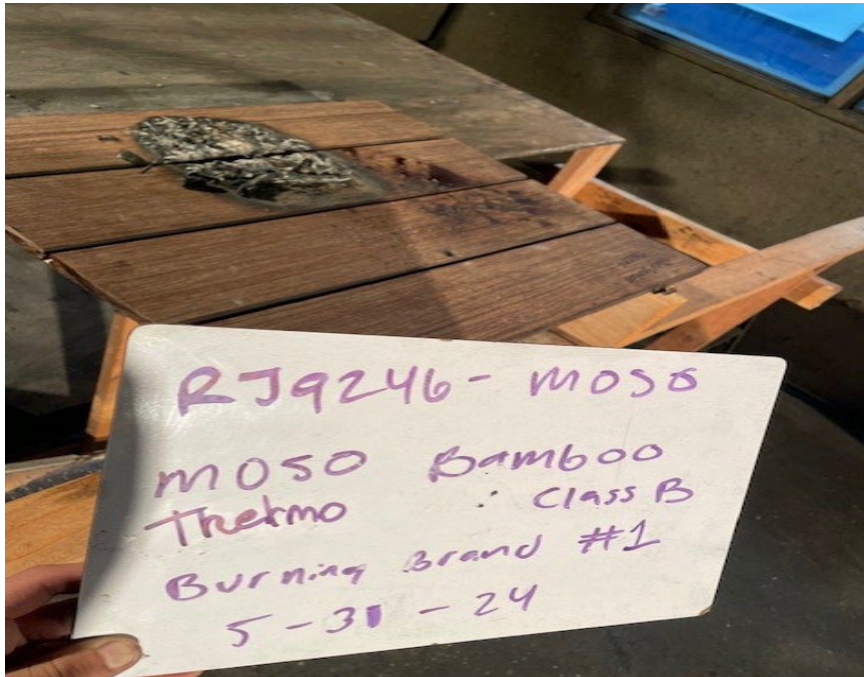
**Photograph 2: Test #1 post test**
